Maruti Baleno 2015-2022 1.2 Delta

RJ14*****
Registration number

Summary

Overall Score 7.5 /10

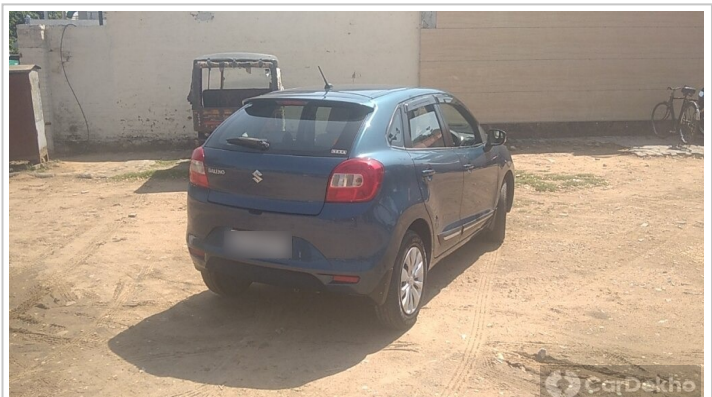
Right Quarter Panel

- ✓ A pillar Left : Good
- ✓ A pillar Right : Good
- ✗ Quarter Panel Left : Dented > 10SqCm, Scratched < 5Cm
- ✓ Quarter Panel Robotic Punches Original : Yes
- ✗ Running Board Left : Scratched
- ✓ Dickey Floor and Back end Panel : Good
- ✓ B pillar Left : Good
- ✓ B pillar Right : Good
- ✗ Quarter Panel Right : Scratched (>5Cm)
- ✓ Apron Left : Good
- ✗ Running Board Right : Scratched
- ✓ Front Member (Bonnet Patti) : Good
- ✓ C pillar Left : Good
- ✓ C pillar Right : Good
- ✓ Quarter Panel Robotic Punches Original : Yes
- ✓ Apron Right : Good
- ✓ Running Board Robotic Punches Original : Yes

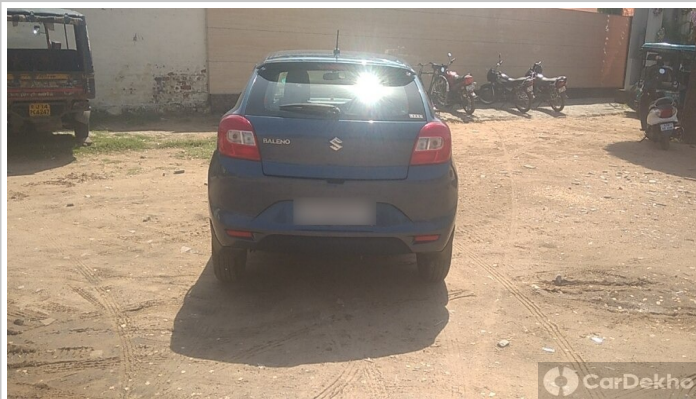
Rear (bumper, dicky door, rr-windshield, tail lights)

- ✗ Front Bumper : Scratched, Replaced
- ✗ Fender Left : Dented (>10SqCm), Scratched (>5Cm)
- ✗ Rear Door Right : Dented (<10SqCm), Scratched (>5Cm)
- ✗ Dicky/ Boot Door : Scratched (>5Cm)
- ✗ Rear Windshield : Spotted, Scratched
- ✓ Cowl top : Good
- ✓ Lamp support : Good
- ✗ Bonnet Quality : Repainted, Repaired, Scratched (<5Cm)
- ✗ Fender Right : Repainted, Scratched (>5Cm)
- ✗ Rear Door Left : Dented (<10SqCm), Dented (>10SqCm), Scratched (<5Cm), Scratched (>5Cm)
- ✗ Roof Quality : Dented (<10SqCm), Scratched (<5Cm)
- ✗ ORVM Right : Scratched
- ✓ Firewall : Good
- ✗ Side member : Rusted
- ✗ Front Windshield : Spotted
- ✗ Front Door Right : Scratched (>5Cm)
- ✗ Front Door Left : Dented (<10SqCm), Scratched (>5Cm)
- ✗ Rear Bumper : Dented, Scratched
- ✓ ORVM Left : Working
- ✓ Lower Member : Good

- ✗ Head Light Left : Scratched
- ✗ Tail Light Left : Damaged
- ✗ Head Light Right : Scratched
- ✓ Tail Light Right : Good

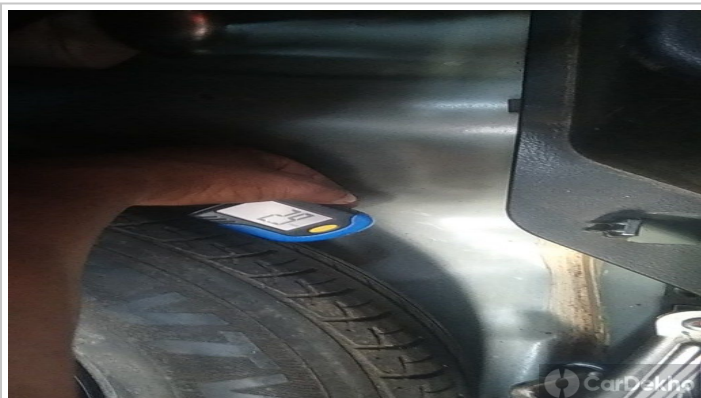
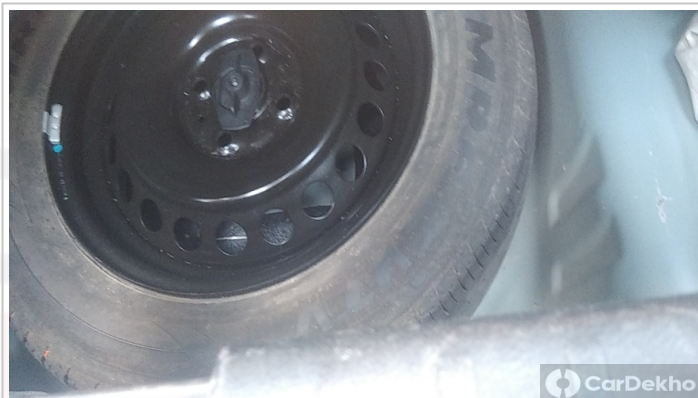
Spare Tyre

- ✓ Right Front Tyre tread depth : 50-75%
- ✓ Rear Left Tyre tread depth : 50-75%
- ✓ Right Rear Tyre tread depth : 50-75%
- ✗ Spare tyre Available : Not Available
- ✓ Front Left Tyre tread depth : 50-75%
- ✗ Alloy wheels : No

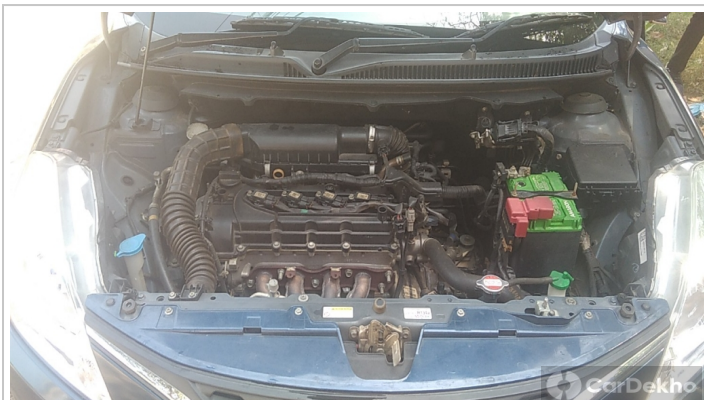
Engine Compartment

- ✓ Engine Mountings/Structure : Good
- ✗ Coolant : Dirty
- ✓ Smoke Colour/ Exhaust Emission : Colourless
- ✗ Blowby/Back compression : Oil Spillage on Idle
- ✓ Engine Sound/ Engine Noise : Normal
- ✓ Radiator : Good
- ✓ Gear Shifting mechanism performance : Smooth
- ✓ Manifold Catalytic Converter/ Silencer Mitti : Available
- ✗ Engine Oil : Dirty
- ✓ Radiator Fan : Working
- ✓ Blower Motor Noise : Normal
