Maruti Baleno 2015-2022 1.2 Delta

Jaipur (first) Rto, Rajasthan RTO	RJ14***** Registration number
01-09-2017 Manufacturing Date	12-10-2017 Registration Date
1 No. of Owners	75791 Odometer Reading #
Petrol Fuel Type	Manual Transmission
Blue Color

Overall Score 7 /10

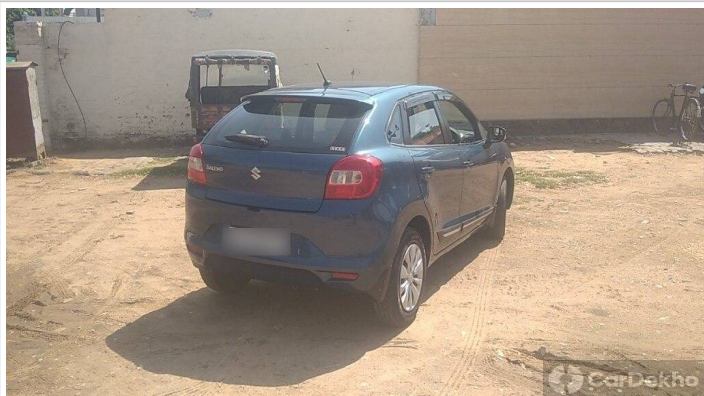
Right Quarter Panel

- ✓ A pillar Left : Good
- ✓ A pillar Right : Good
- ✗ Quarter Panel Left : Dented > 10SqCm, Scratched 5Cm
- ✓ Quarter Panel Robotic Punches Original : Yes
- ✗ Running Board Left : Scratched
- ✓ Dickey Floor and Back end Panel : Good
- ✓ B pillar Left : Good
- ✓ B pillar Right : Good
- ✗ Quarter Panel Right : Scratched (>5Cm)
- ✓ Apron Left : Good
- ✗ Running Board Right : Scratched
- ✓ Front Member (Bonnet Patti) : Good
- ✓ C pillar Left : Good
- ✓ C pillar Right : Good
- ✓ Quarter Panel Robotic Punches Original : Yes
- ✓ Apron Right : Good
- ✓ Running Board Robotic Punches Original : Yes

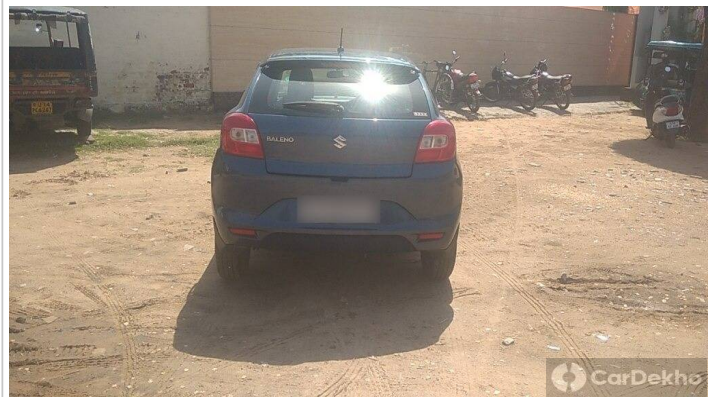
Rear (bumper, dicky door, rr-windshield, tail lights)

- ✗ Front Bumper : Scratched, Replaced
- ✗ Fender Left : Dented (>10SqCm), Scratched (>5Cm)
- ✗ Rear Door Right : Dented (10SqCm), Scratched (>5Cm)
- ✗ Dicky/ Boot Door : Scratched (>5Cm)
- ✗ Rear Windshield : Spotted, Scratched
- ✓ Cowl top : Good
- ✓ Lamp support : Good
- ✗ Bonnet Quality : Repainted, Repaired, Scratched (5Cm)
- ✗ Fender Right : Repainted, Scratched (>5Cm)
- ✗ Rear Door Left : Dented (10SqCm), Dented (>10SqCm), Scratched (5Cm), Scratched (>5Cm)
- ✗ Roof Quality : Dented (10SqCm), Scratched (5Cm)
- ✗ ORVM Right Manual : Scratched
- ✓ Firewall : Good
- ✗ Side member : Rusted
- ✗ Front Windshield : Spotted
- ✗ Front Door Right : Scratched (>5Cm)
- ✗ Front Door Left : Dented (10SqCm), Scratched (>5Cm)
- ✗ Rear Bumper : Dented, Scratched
- ✓ ORVM Left Manual : Working
- ✓ Lower Member : Good

- ✗ Head Light Left : Scratched
- ✗ Tail Light Left : Damaged
- ✗ Head Light Right : Scratched
- ✓ Tail Light Right : Good

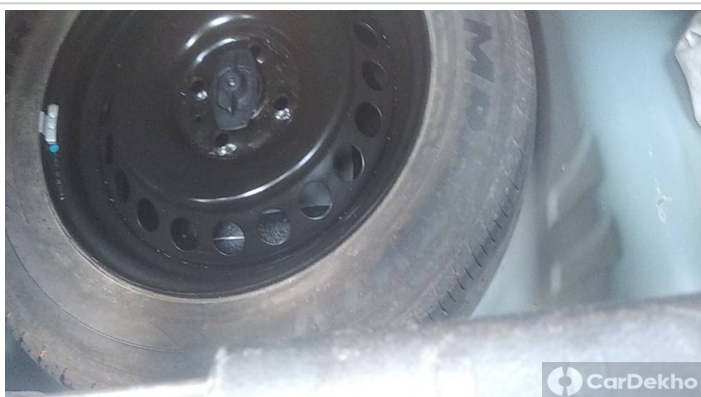
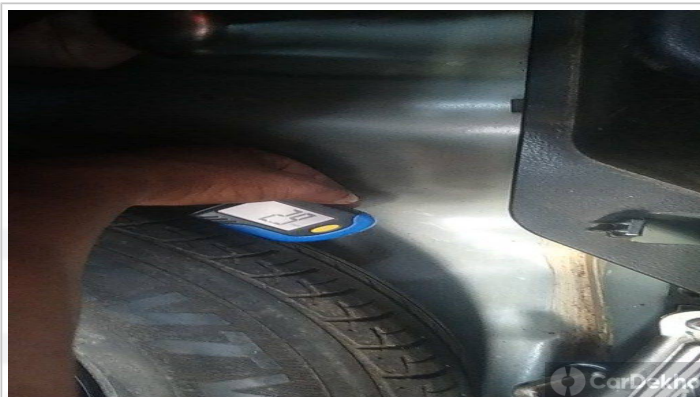
Spare Tyre

- ✓ Right Front Tyre tread depth : 50-75%
- ✓ Rear Left Tyre tread depth : 50-75%
- ✓ Right Rear Tyre tread depth : 50-75%
- ✗ Spare tyre Available : Not Available
- ✓ Front Left Tyre tread depth : 50-75%
- ✗ Alloy wheels : No

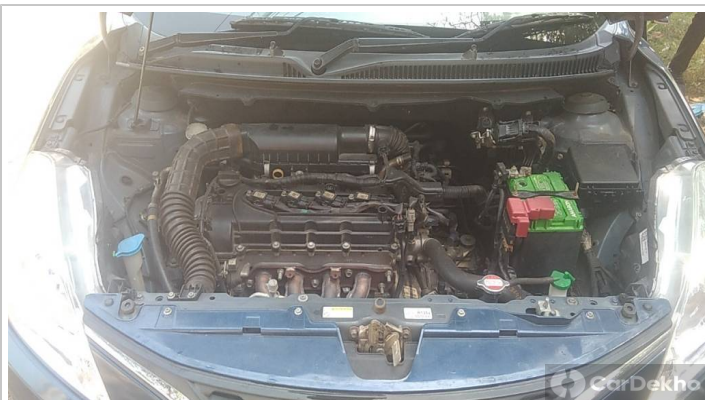
Engine Compartment

- ✓ Engine Mountings/Structure : Good
- ✗ Coolant : Dirty
- ✓ Smoke Colour/ Exhaust Emission : Colourless
- ✗ Blowby/Back compression : Oil Spillage on Idle
- ✓ Engine Sound/ Engine Noise : Normal
- ✓ Radiator : Good
- ✓ Gear Shifting mechanism performance : Smooth
- ✓ Manifold Catalytic Converter/ Silencer Mitti : Available
- ✗ Engine Oil : Dirty
- ✓ Radiator Fan : Working
- ✓ Blower Motor Noise : Normal
