Maruti Baleno 2015-2022 1.2 Delta

Jaipur (first) Rto, Rajasthan RTO	RJ14****** Registration number
01-09-2017 Manufacturing Date	12-10-2017 Registration Date
1 No. of Owners	75791 Odometer Reading #
Petrol Fuel Type	Manual Transmission
Prme. Ray Blue Color

Summary

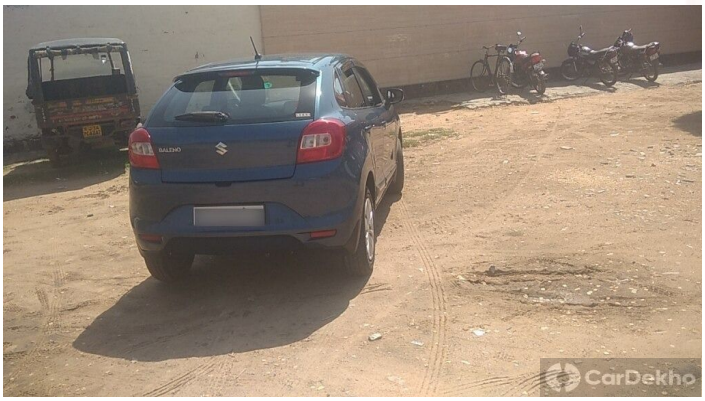
Right Side (fender, doors, qtr Panel) View

- ✗ Front Bumper : Scratched, Replaced
- ✗ Fender Left : Dented (>10SqCm), Scratched (>5Cm)
- ✗ Rear Door Right : Dented (10SqCm), Scratched (>5Cm)
- ✗ Dicky/ Boot Door : Scratched (>5Cm)
- ✗ Rear Windshield : Spotted, Scratched
- ✓ Cowl top : Good
- ✓ Lamp support : Good
- ✗ Bonnet Quality : Repainted, Repaired, Scratched (5Cm)
- ✗ Fender Right : Repainted, Scratched (>5Cm)
- ✗ Rear Door Left : Dented (10SqCm), Dented (>10SqCm), Scratched (5Cm), Scratched (>5Cm)
- ✗ Roof Quality : Dented (10SqCm), Scratched (5Cm)
- ✗ ORVM Right Manual : Scratched
- ✓ Firewall : Good
- ✗ Side member : Rusted
- ✗ Front Windshield : Spotted
- ✗ Front Door Right : Scratched (>5Cm)
- ✗ Front Door Left : Dented (10SqCm), Scratched (>5Cm)
- ✗ Rear Bumper : Dented, Scratched
- ✓ ORVM Left Manual : Working
- ✓ Lower Member : Good

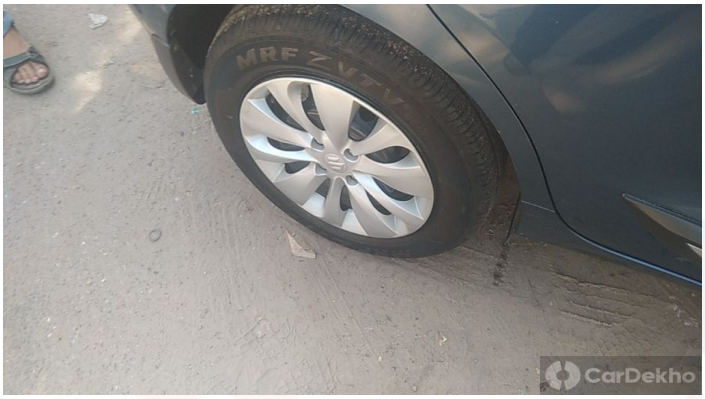
Rear Right Tyre View

- ✓ Right Front Tyre tread depth : 50-75%
- ✓ Right Rear Tyre tread depth : 50-75%
- ✓ Front Left Tyre tread depth : 50-75%
- ✓ Rear Left Tyre tread depth : 50-75%
- ✗ Spare tyre Available : Not Available
- ✗ Alloy wheels : No
