Maruti Baleno 2015-2022 1.2 Delta

RJ14*****
Registration number

Summary

Overall Score 7.5 /10

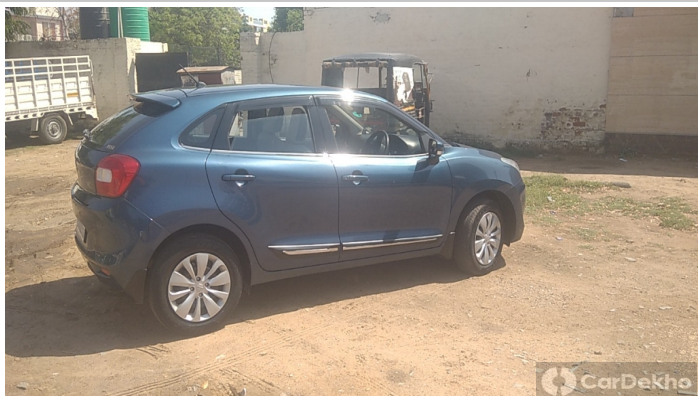
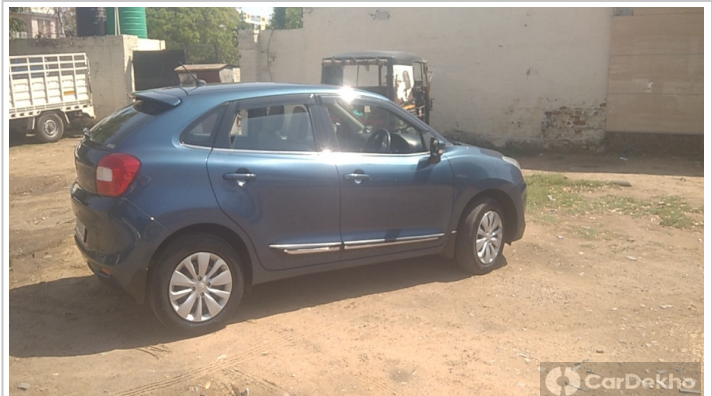
Right Side (fender, doors, qtr Panel)

- ✓ A pillar Left : Good
- ✓ A pillar Right : Good
- ✗ Quarter Panel Left : Dented > 10SqCm, Scratched < 5Cm
- ✓ Quarter Panel Robotic Punches Original : Yes
- ✗ Running Board Left : Scratched
- ✓ Dickey Floor and Back end Panel : Good
- ✓ B pillar Left : Good
- ✓ B pillar Right : Good
- ✗ Quarter Panel Right : Scratched (>5Cm)
- ✓ Apron Left : Good
- ✗ Running Board Right : Scratched
- ✓ Front Member (Bonnet Patti) : Good
- ✓ C pillar Left : Good
- ✓ C pillar Right : Good
- ✓ Quarter Panel Robotic Punches Original : Yes
- ✓ Apron Right : Good
- ✓ Running Board Robotic Punches Original : Yes

- ✗ Front Bumper : Scratched, Replaced
- ✗ Fender Left : Dented (>10SqCm), Scratched (>5Cm)
- ✗ Rear Door Right : Dented (<10SqCm), Scratched (>5Cm)
- ✗ Dicky/ Boot Door : Scratched (>5Cm)
- ✗ Rear Windshield : Spotted, Scratched
- ✓ Cowl top : Good
- ✓ Lamp support : Good
- ✗ Bonnet Quality : Repainted, Repaired, Scratched (<5Cm)
- ✗ Fender Right : Repainted, Scratched (>5Cm)
- ✗ Rear Door Left : Dented (<10SqCm), Dented (>10SqCm), Scratched (<5Cm), Scratched (>5Cm)
- ✗ Roof Quality : Dented (<10SqCm), Scratched (<5Cm)
- ✗ ORVM Right : Scratched
- ✓ Firewall : Good
- ✗ Side member : Rusted
- ✗ Front Windshield : Spotted
- ✗ Front Door Right : Scratched (>5Cm)
- ✗ Front Door Left : Dented (<10SqCm), Scratched (>5Cm)
- ✗ Rear Bumper : Dented, Scratched
- ✓ ORVM Left : Working
- ✓ Lower Member : Good

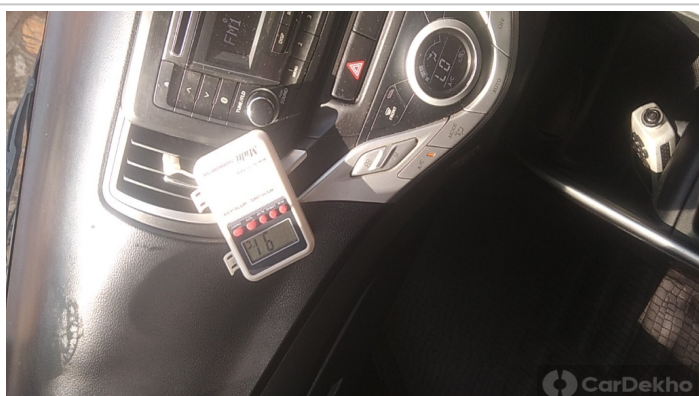
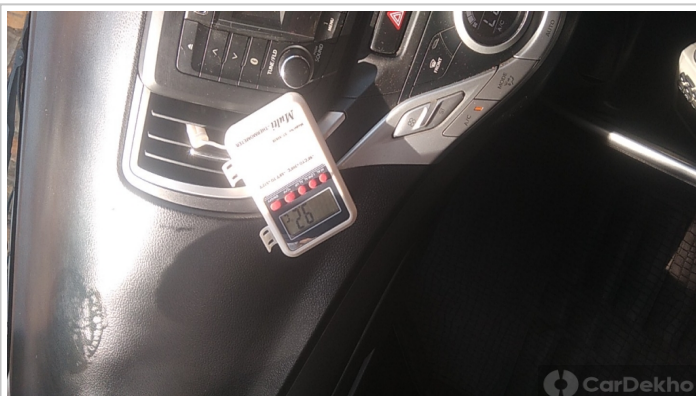
Ac Cooling image

- ✓ AC Cooling : Satisfactory
- ✗ Dash Board/Glove box : Scratched
- ✓ Floor carpet : Good
- ✓ Heater : Working
- ✗ Seat Cover : Torn
- ✓ Auto Climate AC : Working
- ✓ Music system : Working
- ✓ Roof carpet : Good

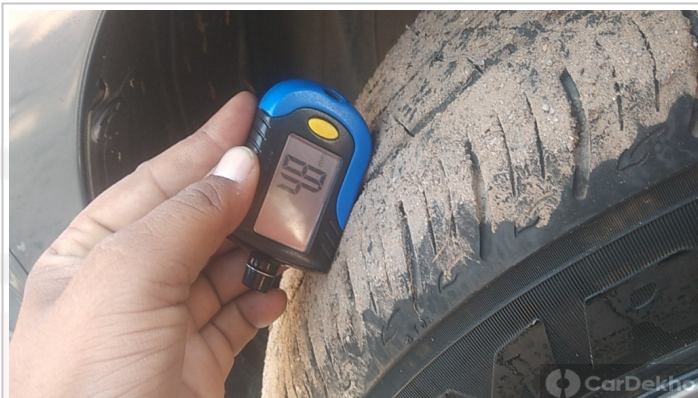
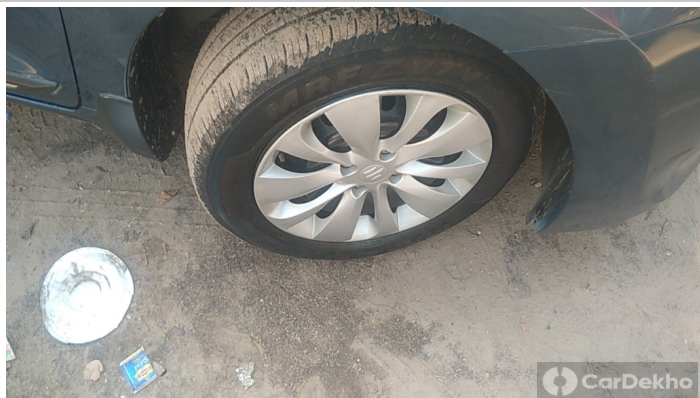
Front Right Tyre

- ✓ Right Front Tyre tread depth : 50-75%
- ✓ Rear Left Tyre tread depth : 50-75%
- ✓ Right Rear Tyre tread depth : 50-75%
- ✗ Spare tyre Available : Not Available
- ✓ Front Left Tyre tread depth : 50-75%
- ✗ Alloy wheels : No
