Maruti Baleno 2015-2022 1.2 Delta

Jaipur (first) Rto, Rajasthan RTO	RJ14***** Registration number
01-09-2017 Manufacturing Date	12-10-2017 Registration Date
1 No. of Owners	75791 Odometer Reading #
Petrol Fuel Type	Manual Transmission
Blue Color

Overall Score 7 /10

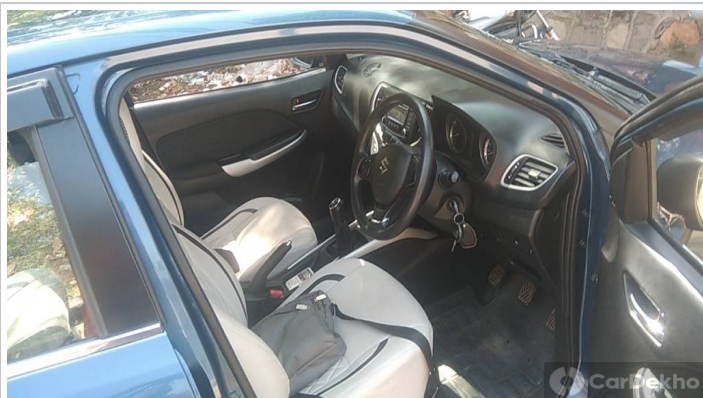
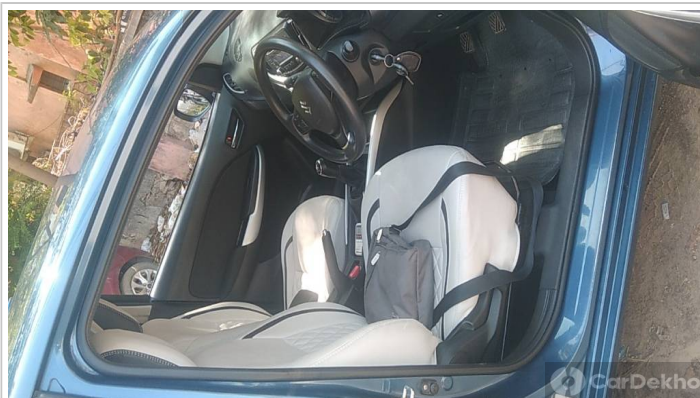
Front Right or Left Side Interior View

- ✓ AC Cooling : Satisfactory
- ✗ Dash Board/Glove box : Scratched
- ✓ Floor carpet : Good
- ✓ Heater : Working
- ✗ Seat Cover : Torn
- ✓ Auto Climate AC : Working
- ✓ Music system : Working
- ✓ Roof carpet : Good

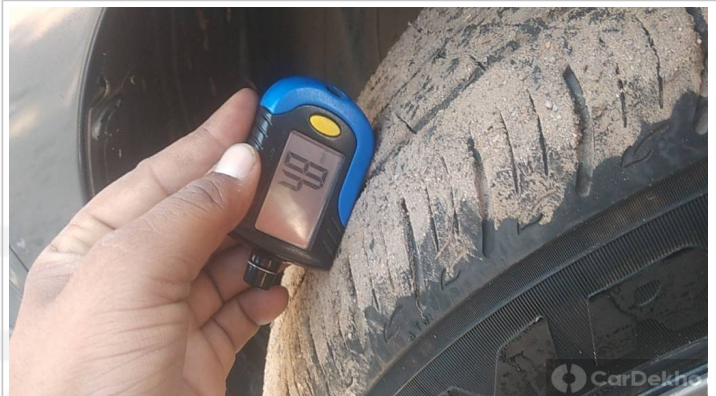
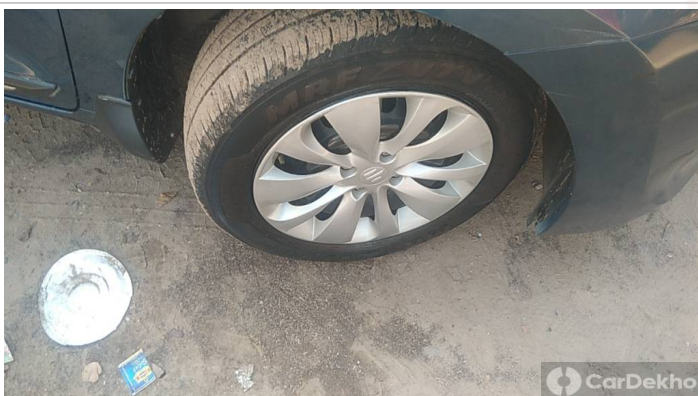
Front Right Tyre

- ✓ Right Front Tyre tread depth : 50-75%
- ✓ Rear Left Tyre tread depth : 50-75%
- ✓ Right Rear Tyre tread depth : 50-75%
- ✗ Spare tyre Available : Not Available
- ✓ Front Left Tyre tread depth : 50-75%
- ✗ Alloy wheels : No
